SERVICEGRAM

VOL. 4 NO. 1

What's Causing the Noise? Common Noise Complaints on Popular CUV, SUV and Pass Car Applications

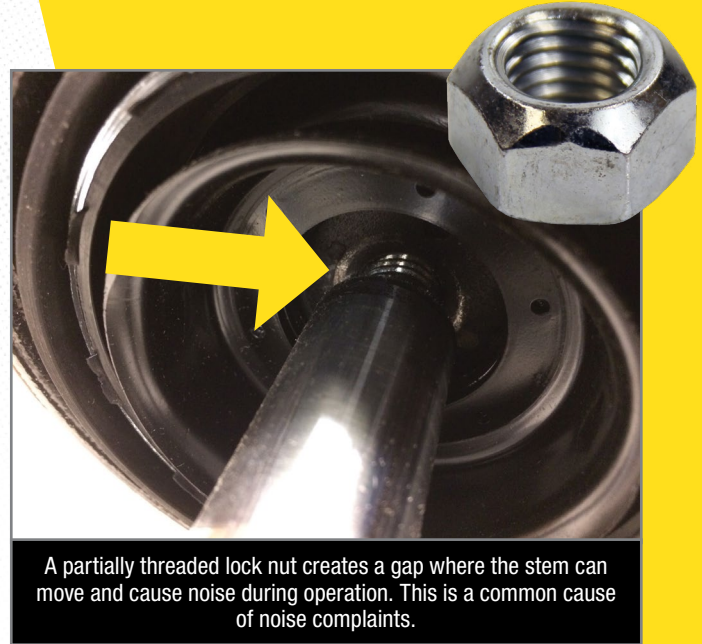
Noise issues related to new replacement ride control units on popular CUV, SUV and passenger car applications can be caused by distorted, threaded lock nuts. The lock nut design as well as manufacturing process is critical to noise-free performance for certain applications, noted in the chart below.

On these vehicles, if the nut is over crimped, it can be difficult to thread on the stem. This results in a gap between the rod and mount where the stem can move, often leading to unwanted noise.
